Effects of Aging and Environmental Conditions on Ammunition/Explosives Storage Magazines – Paper 2

Abstract

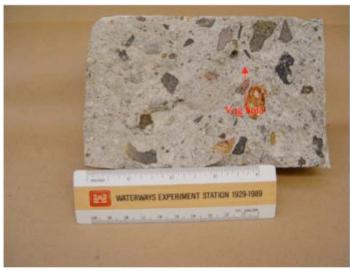
Figure 9. Concrete core from ECM.

The aggregate particles in all of the core samples exhibit very dense and hard characteristics. The aggregates in the concrete cores that were sampled appeared well sorted, with little to no segregation or poorly consolidated concrete (Figure 9).

However, there are some small vug holes that were noticed in one of the cores (Figure 9). These vug holes are generally caused by poor, improper, or incomplete consolidation of the concrete. Yet, it is impossible to get all the entrapped air out of the concrete, and the vug holes noted in these cores are minor.

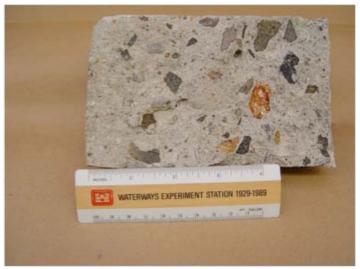
Figure 10. Freshly broken core sample for application of phenolphthalein.

The carbonation test required a core sample to be broken so that a fresh surface could be saturated with phenolphthalein. Once the fresh broken surface had been saturated, the color of the concrete would change to purple if the concrete's pH is above 9.5. Figure 10 shows the freshly broken surface of a concrete core. Figure 11 shows the same core surface after phenolphthalein has been applied.

As can be seen in Figure 11, the pH has dropped around the concrete surface of the cores, however the internal portion of the core has a pH higher than 9.5. As can be seen Figure 11 below, the carbonation is severe at a depth of 3/4 inch and has moderate carbonation to a depth of

2 inches. The average depth of carbonation on all of the cores from Sierra is roughly 1½ inches. This condition is favorable for inhibiting steel corrosion provided the reinforcing steel has sufficient concrete cover. Table 2 details the average depth of carbonation for the different samples.

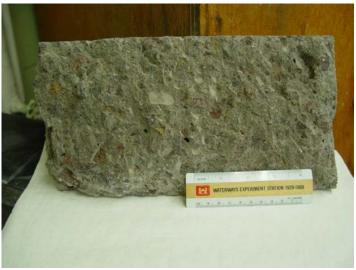
Figure 12. Core sample prepared for ASR staining test.

The ASR staining method uses a freshly broken surface of concrete. A core specimen was prepared by breaking open a core to provide a fresh surface. The concrete was washed and loose material was removed (Figure 12), and the sample was then treated with the two stains to determine if any ASR gel was present. The color change from the application of both, sodium cobaltinitrite (Figure 13), and rhodamine B (Figure 14) indicated a lack of ASR gel.

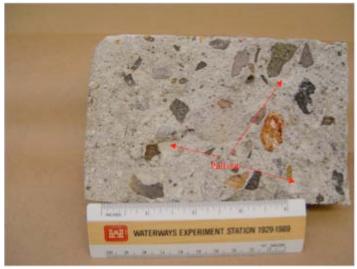
Figure 15. Fractured surface of concrete core (taken from Sierra).

The compressive strength data reported in Table 3 indicate strong, sound concrete with a minimum compressive strength of 3092 psi recorded. In the compressive strength tests, there were very few coarse aggregate pullouts, which indicate that there is a strong bond between the paste and aggregate (Figure 15).

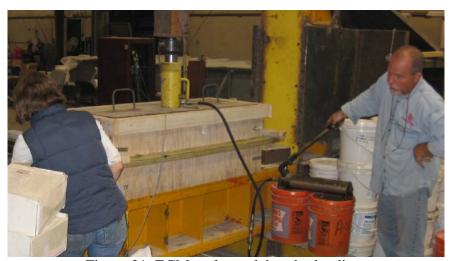
Figure 21. ECM scale model under loading.

The scale model ECM was then loaded to failure in the University of Oklahoma's Donald G. Fears Structural Engineering Laboratory, as shown in Figure 21. The model was placed in a box and covered with sand. The sand was then covered with a large steel plate to distribute the load evenly, and a load cell was applied to the top of the plate. There was a hole in the bottom of the box that allowed a camera to be placed inside the structure to monitor the structure during loading.

Scale Model Results - The structure was loaded to 5,000 lbs, where cracks were observed. The load cell was increased and the structure was loaded to 11,600 lbs. At this point the structure had many cracks and a distinct crack pattern could be seen, as shown in Figure 22.

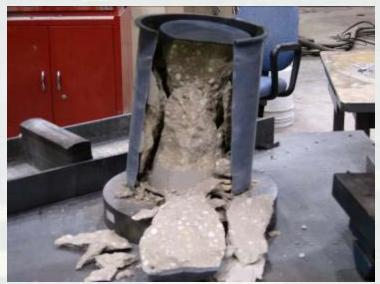
Broken specimen from Compressive Strength test.

All cores were examined in accordance to ASTM C 856 Compressive Strength test (ASTM C 39).

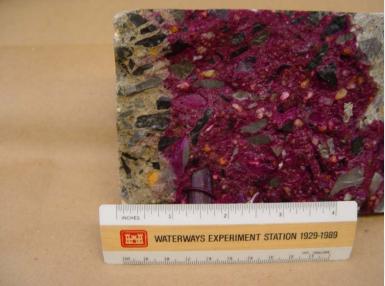
Surface flushed with phenolphthalein.
Notice the dark purple color of the area.

The dark color indicates that the PH of the concrete is above 9.5.
